PUF Performs in Hurricane Hugo

by Daniel Benedict

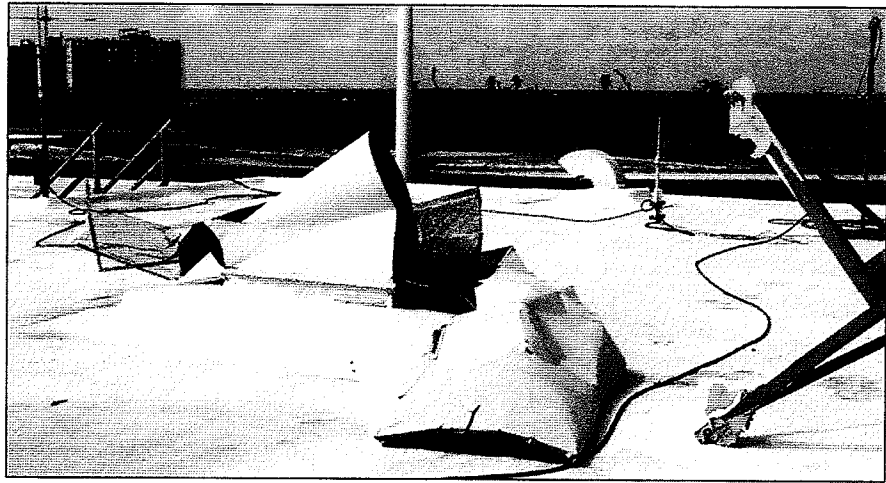
A communications antenna 15

Hurricane Hugo's winds tore the equipment off the roof of this American Airlines terminal in Puerto Rico, but no leaks in the spray polyurethane foam resulted.

feet in diameter had been uprooted and tore a section of the polyurethane foam. Despite this damage, no leaks resulted. The PUF roof had a 55-mil-thick elastomeric coating on it 3-1/2 years old.

A large portion of the American Airlines roof was power-washed and primed after the hurricane and another 15 mils of elastomeric coating applied.

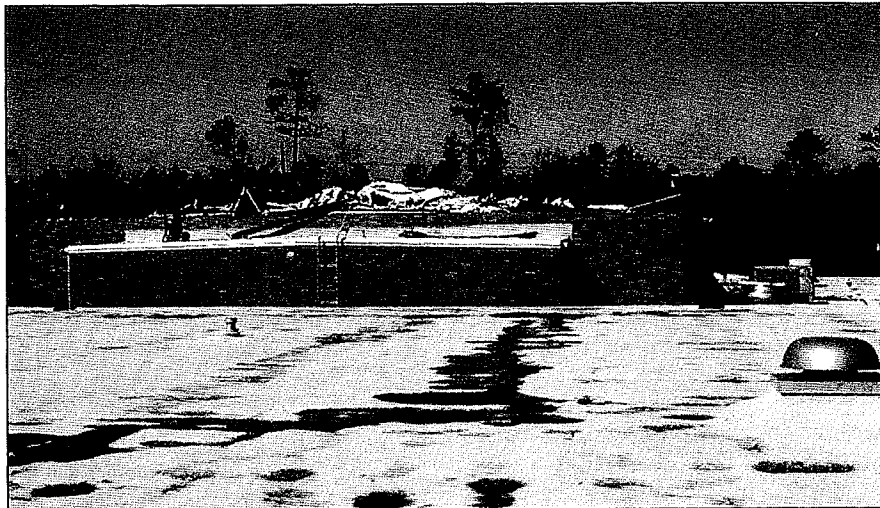
only from falling trees and flying debris. One school needed only minor repairs to the system, with the exception of the gymnasium roof, which originally was a tectum deck. Hugo had lifted off and carried away the majority of this roof, and it was beyond repair.

The spray polyurethane foam roof in the foreground on this high school in the Charleston area endured Hurricane Hugo, but the tectum deck of the gymnasium in the background gave way.
